**Re: Defect Information Report – Supplemental Report No.02  
08V-668, FL-542, MBE 900 EPA04 High Pressure Fuel Lines**

Subject: **Safety Recall 08C3**  
MBE 900 EPA04 High Pressure Fuel Lines

## **Subject: MBE 900 EPA04 High Pressure Fuel Lines**

**SUBJECT:** HIGH PRESSURE FUEL LINES AND TRANSFER TUBES

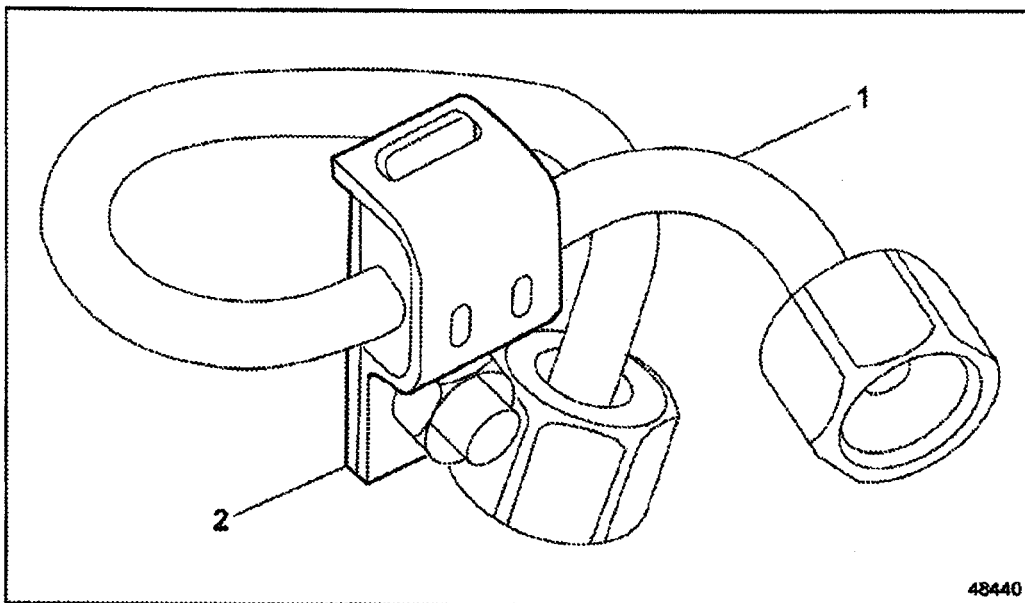
**Figure 2 Damper Clamp Alignment**

1. High Pressure Fuel Line

2. Damper Clamp

1. The new high pressure fuel line comes assembled with the damper clamp. Ensure that the damper clamp is aligned correctly on the high pressure fuel line and is not in contact with surrounding engine components. See Figure 2.

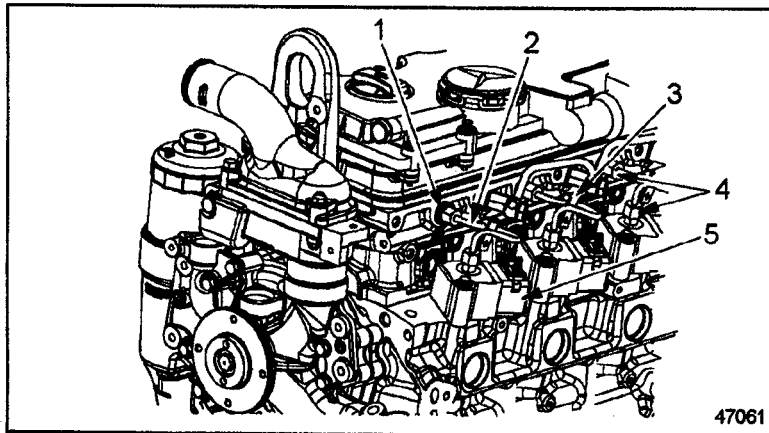
**Figure 3 High Pressure Fuel Line**

| 1. Transfer-Tube Nut | 4. Fuel Lines Nuts |
| 2. High Pressure Fuel Line | 5. Electronic Unit Pump |
| 3. Isolator Clip | |

5. Hand-tighten the high pressure fuel injector line nut first at the unit pump, and then at the transfer tube. While hand tightening the nuts, gently move the high pressure fuel line back and forth to ensure the end of the line is properly seated in the transfer tube and unit pump fitting. If the high pressure fuel injector line has been installed incorrectly and torqued, remove the high pressure fuel injector line and transfer tube and replace with new parts. Ensure that the damper clamp is not touching any other fuel lines or other engine or vehicle components. See Figure 3.
